AHERA Inspection

**Oasis Middle School
3507 Oasis Boulevard
Cape Coral, Florida 33914**

**Report Number: 23-060217-AS
Prepared On: July 7, 2023**

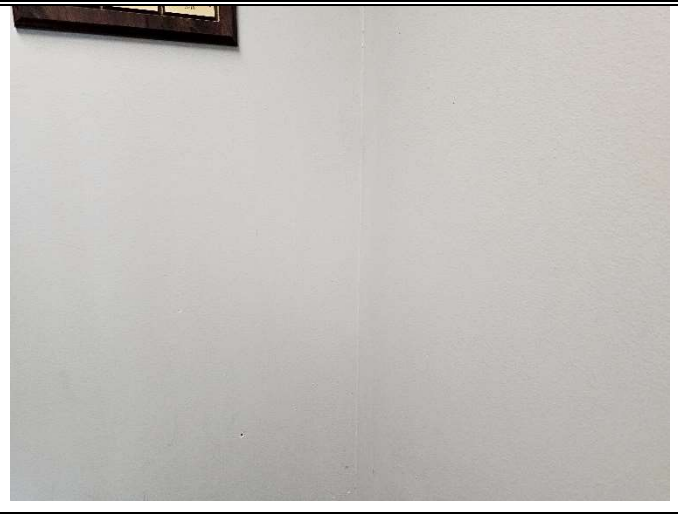
Photo 2: HM-A: Drywall/Joint Compound, White

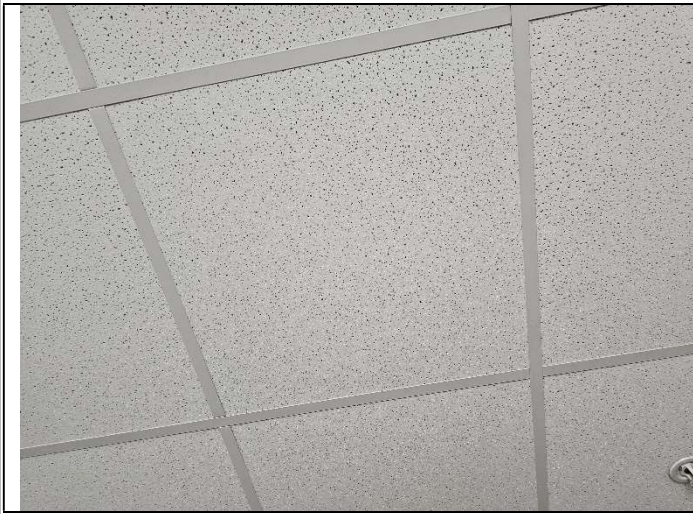
Photo 3: HM-B: 2' x 2' Ceiling Tile, White Pinhole

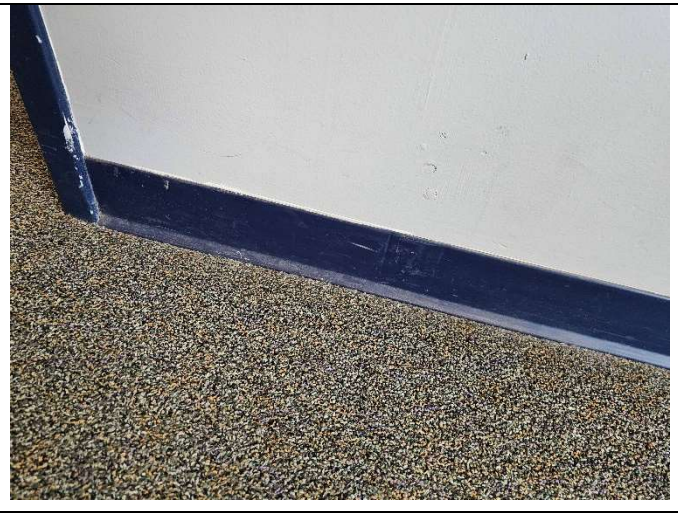
Photo 4: HM-C: Cove Base/Mastic, Navy Blue/Tan

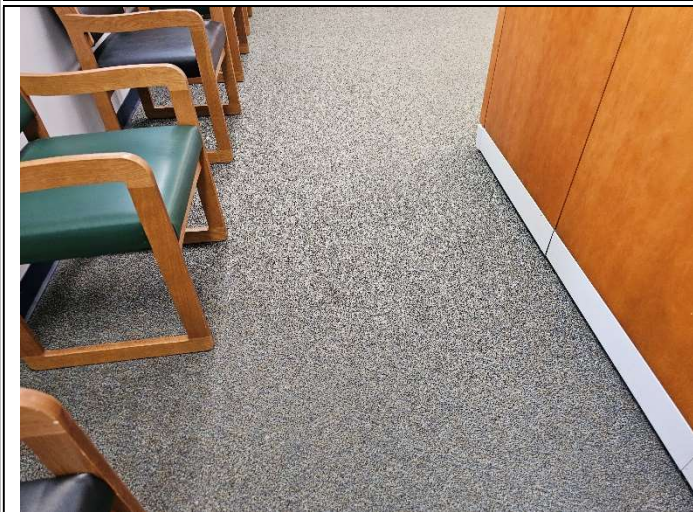
Photo 5: HM-D: Carpet Mastic, Tan

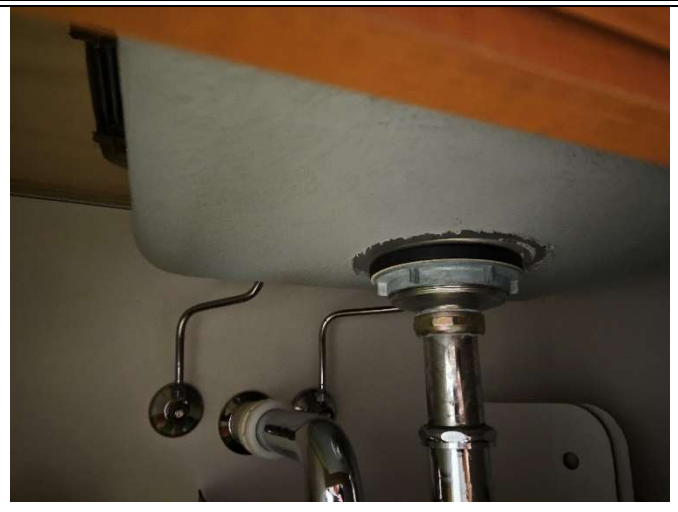
Photo 6: HM-E: Sink Insulation, Gray

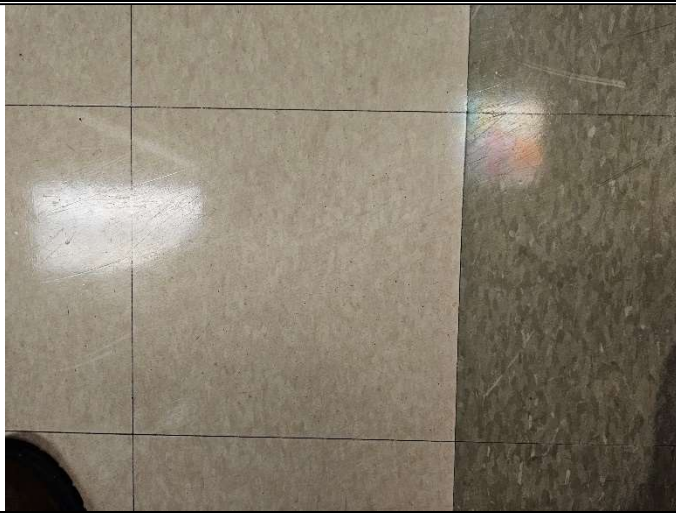
Photo 7: HM-F: 12" x 12" Vinyl Floor Tile, Tan

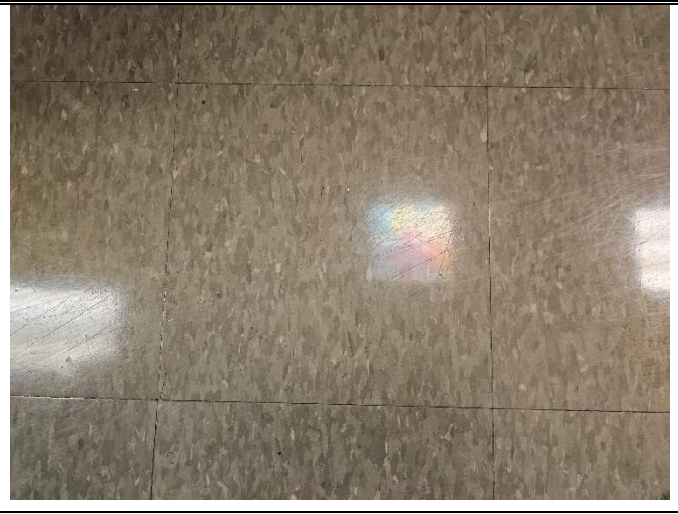
Photo 8: HM-G: 12" x 12" Vinyl Floor Tile, Green

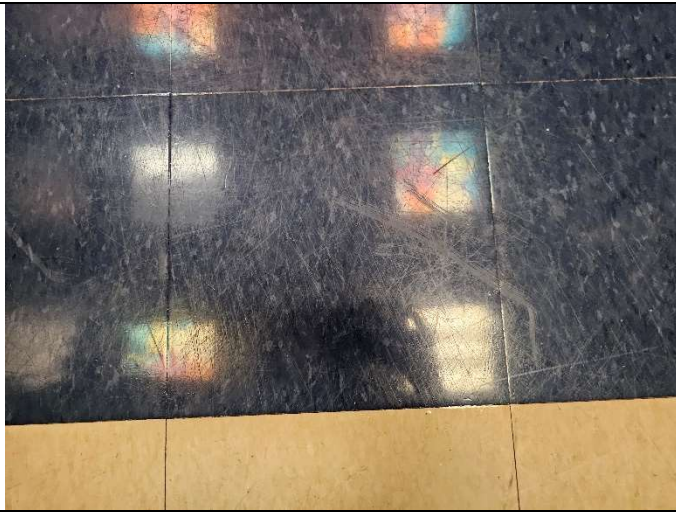
Photo 9: HM-H: 12" x 12" Vinyl Floor Tile, Navy Blue

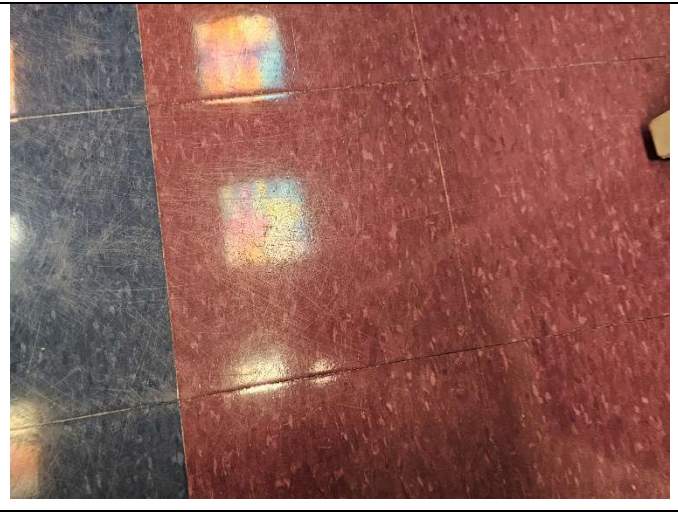
Photo 10: HM-I: 12" x 12" Vinyl Floor Tile, Purple

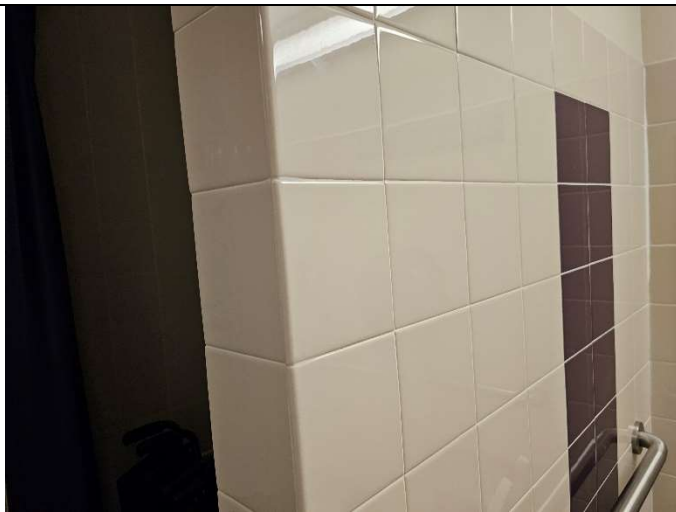
Photo 11: HM-J: 6" Ceramic Wall Tile, Multi-colored

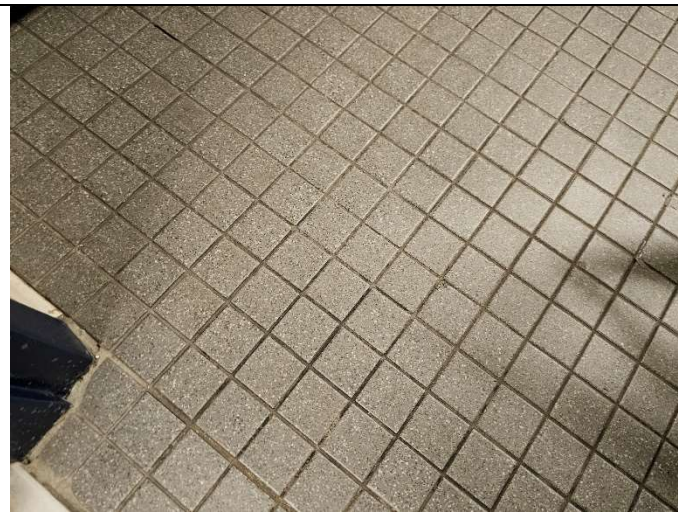
Photo 12: HM-K: 2" Ceramic Tile, Brown

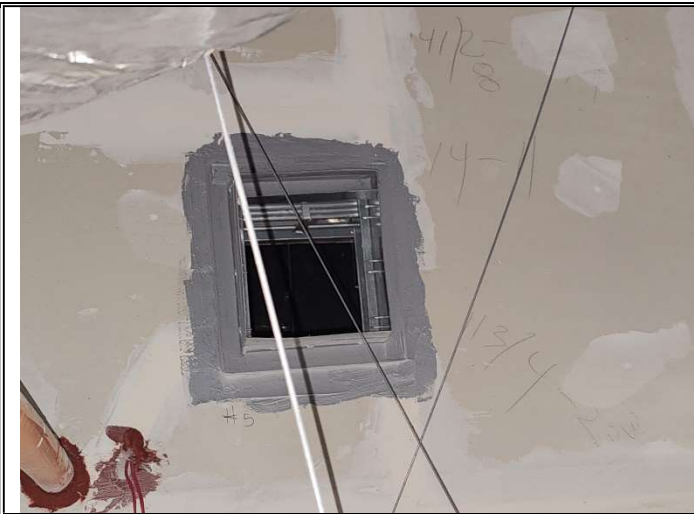
Photo 13: HM-L: Duct Mastic, Gray

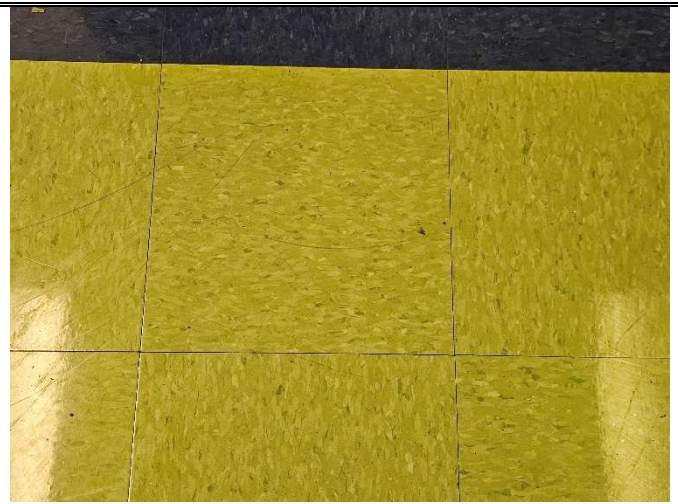
Photo 14: HM-M: 12" x 12" Vinyl Floor Tile, Lime Green

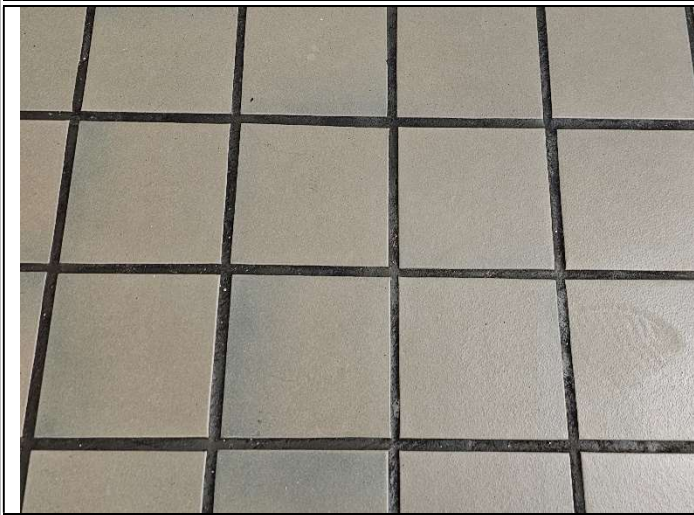
Photo 15: HM-N: 4" Ceramic Tile, Brown

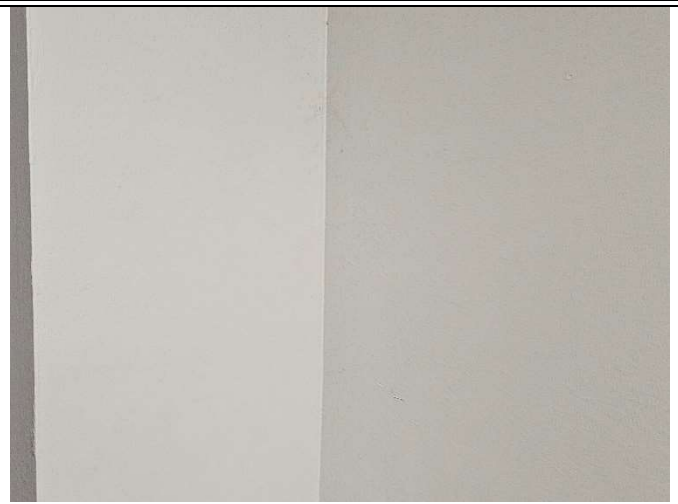
Photo 16: HM-O: Drywall/Joint Compound, White

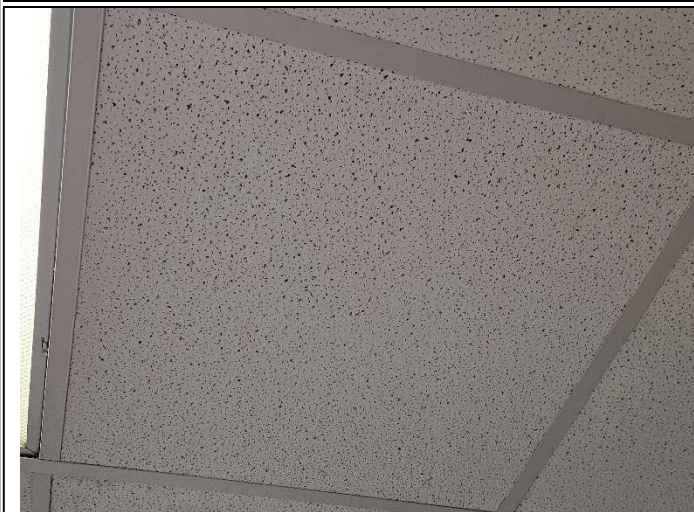
Photo 17: HM-P: 2' x 2' Ceiling Tile, White Pinhole

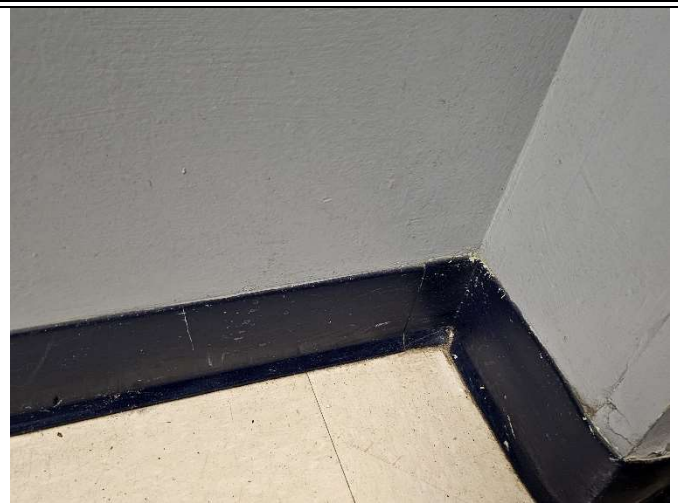
Photo 18: HM-Q: Cove Base/Mastic, Navy Blue/Tan

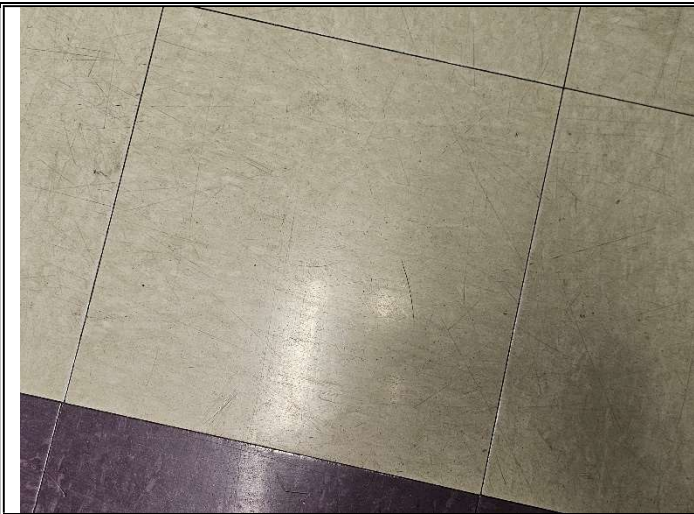
Photo 19: HM-R: 12" x 12" Vinyl Floor Tile, Tan

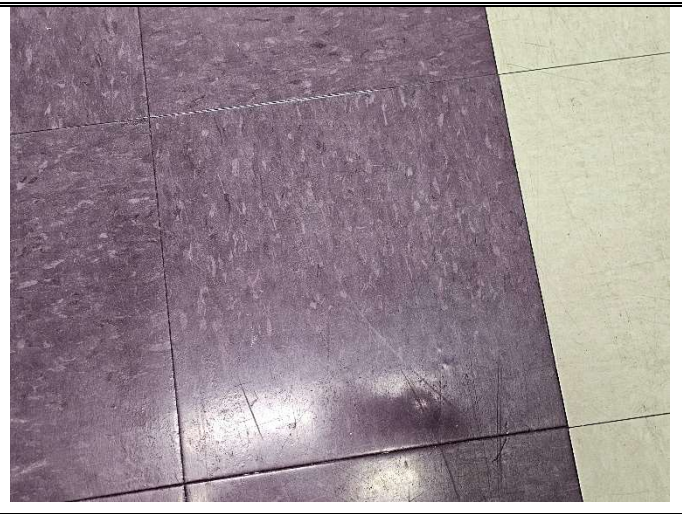
Photo 20: HM-S: 12" x 12" Vinyl Floor Tile, Purple

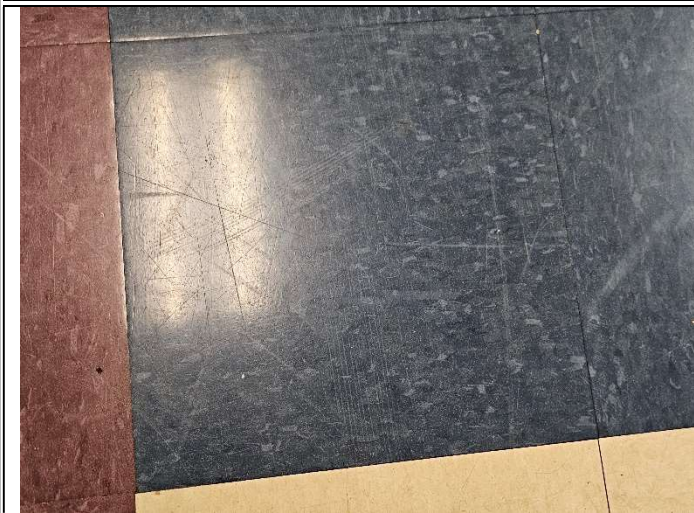
Photo 21: HM-T: 12" x 12" Vinyl Floor Tile, Navy Blue

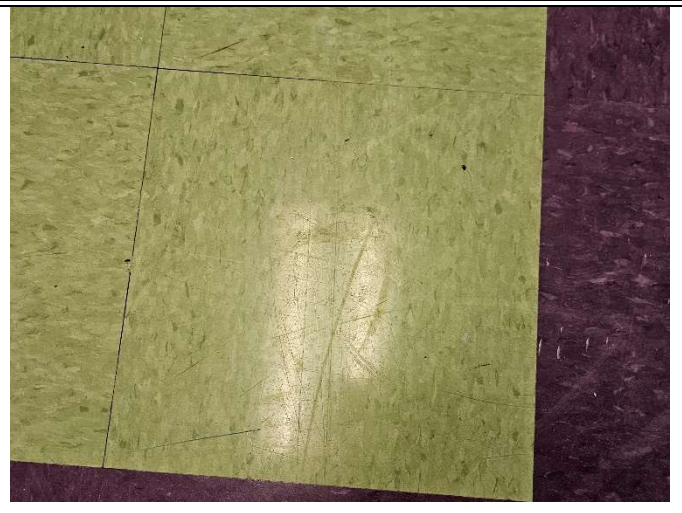
Photo 22: HM-U: 12" x 12" Vinyl Floor Tile, Lime Green

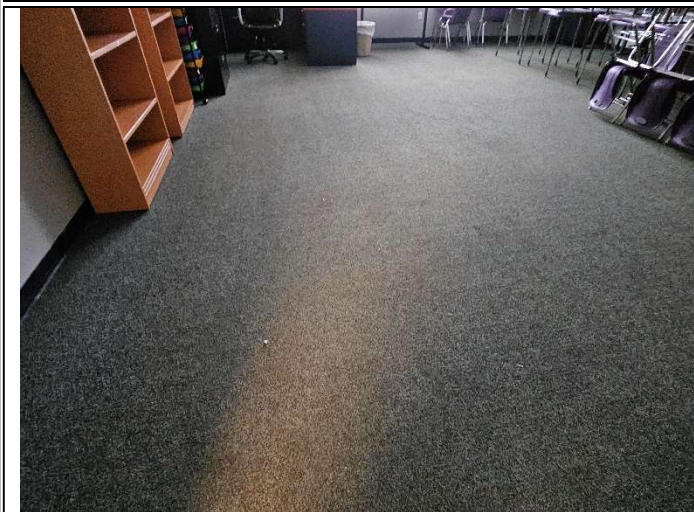
Photo 23: HM-V: Carpet Mastic, Tan

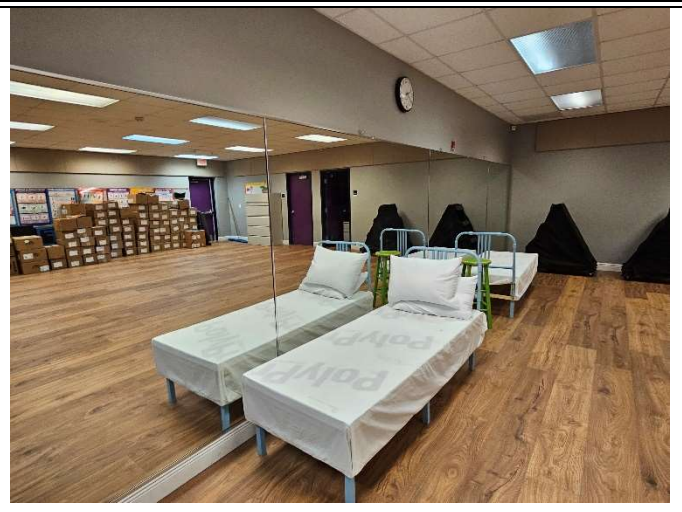
Photo 24: HM-W: Mirror Mastic

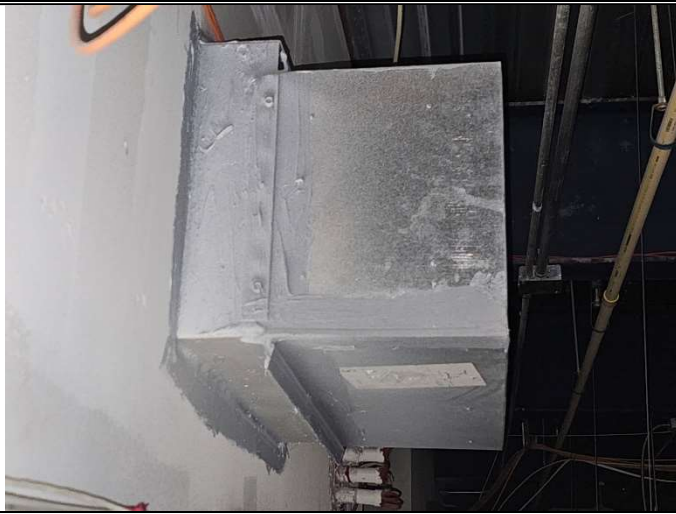
Photo 25: HM-X: Duct Mastic, Gray

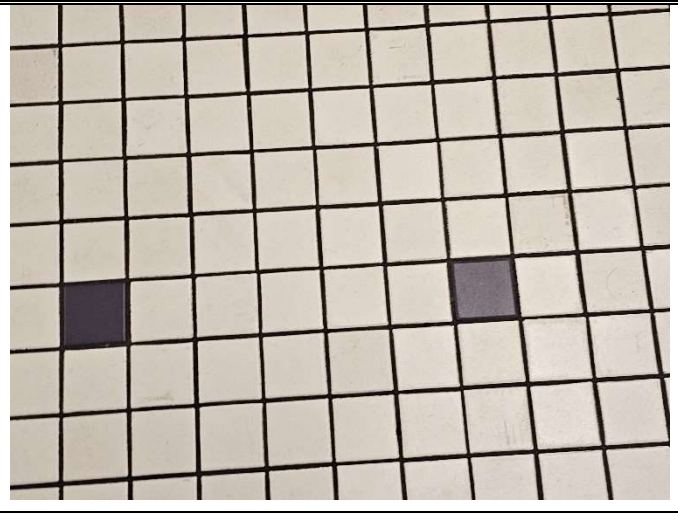
Photo 26: HM-Y: 2" Ceramic Tile, White/Black

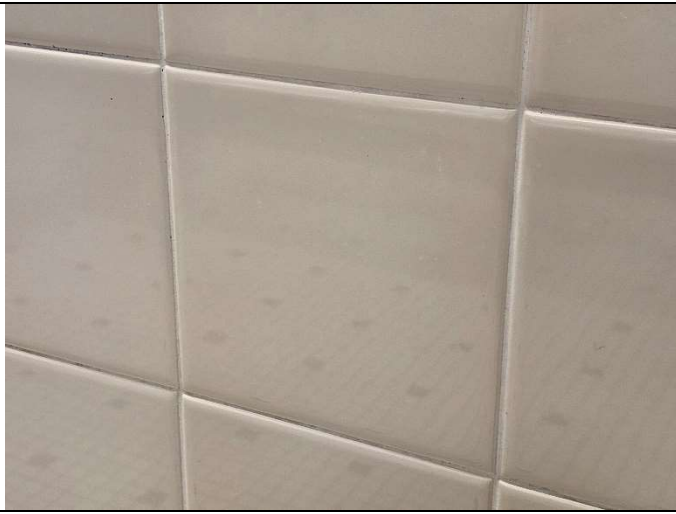
Photo 27: HM-Z: 6" Ceramic Wall Tile, White

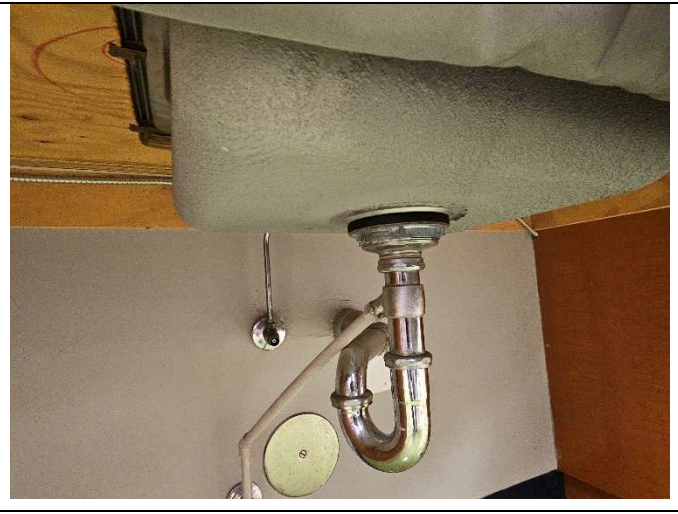
Photo 28: HM-AA: Sink Insulation, Gray

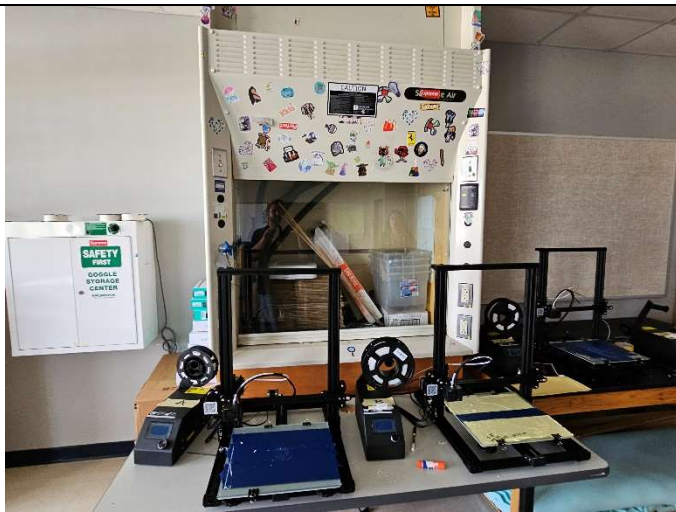
Photo 29: HM-BB: Fume Hood, Tan

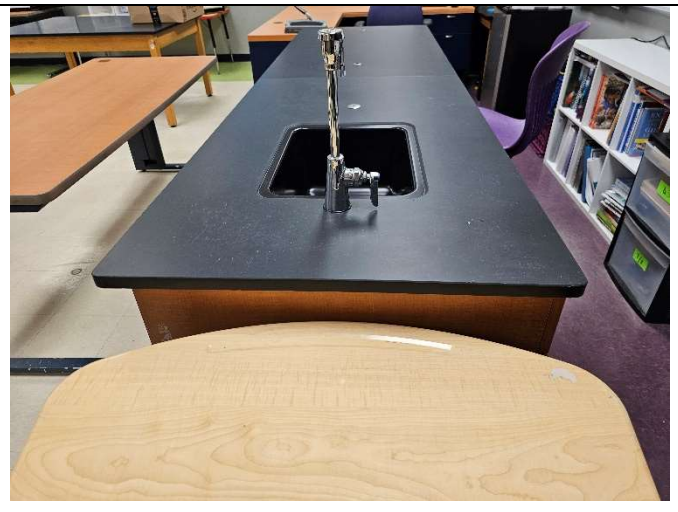
Photo 30: HM-CC: Lab Countertop, Black

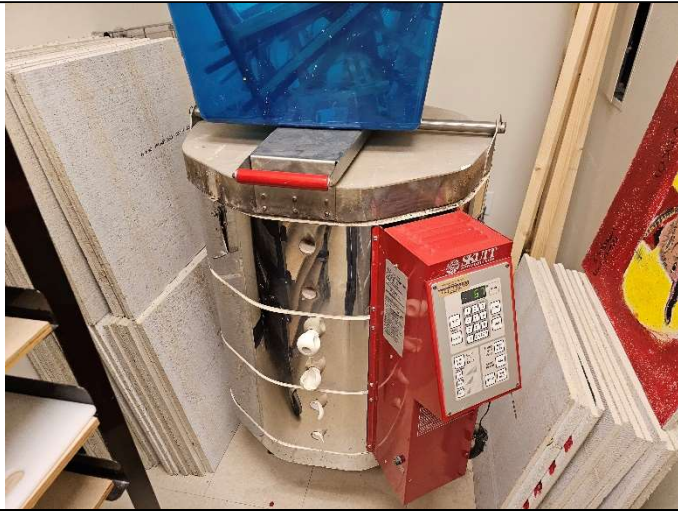
Photo 31: HM-DD: Kiln, Tan

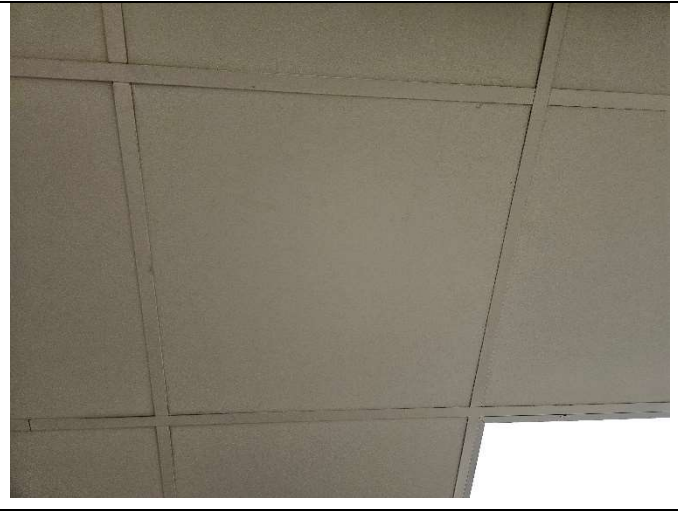
Photo 32: HM-EE: 2' x 2' Drywall Ceiling Tile, White
